**FINAL REPORT  
LANDSIDE PAVEMENT EVALUATION**

**JAX**  
Jacksonville  
International  
Airport

**JANUARY 2012**

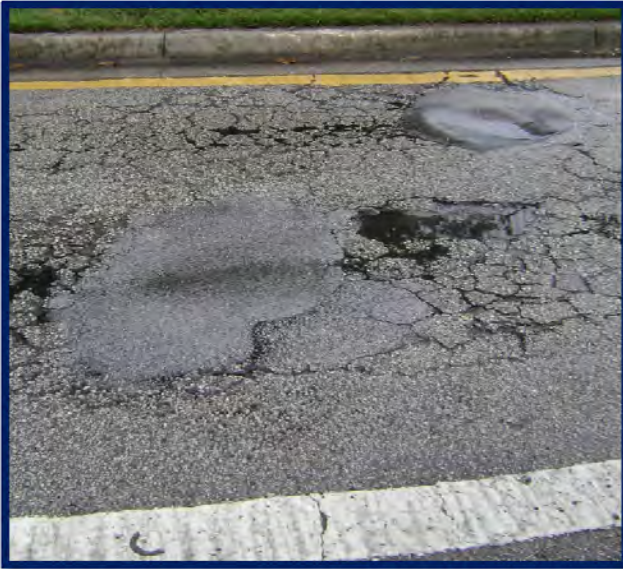
#### 4.1.2.4 Dixie Clipper Road A – Below Critical Value – PCI 14

Dixie Clipper Road Section A is located at the exit of the parking garage. This section was in the worst condition. Distresses included load related alligator cracking and severe rutting. At this location there is a stop sign prior to entering the terminal loop road, which is causing a significant amount of point load.

Distresses of this magnitude require complete reconstruction to the pavement section. It is recommended to provide concrete pavement through this section as well as tie in to the bus exit area where similar distresses are

found. Concrete pavement holds up well under point load conditions. The schematic cost estimate of construction is \$40,224.

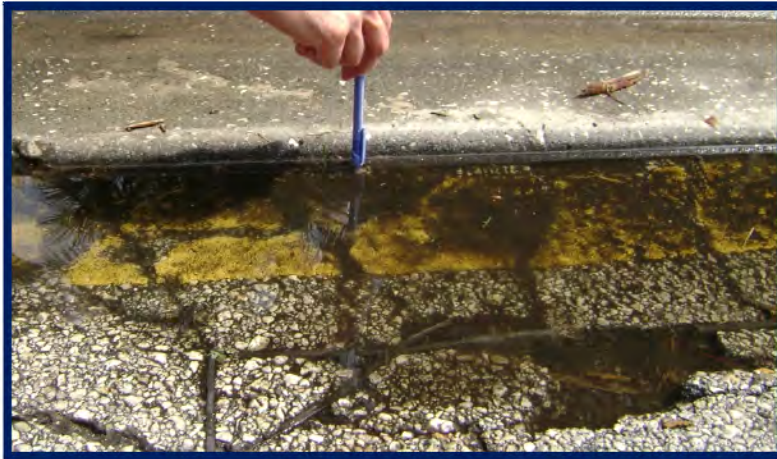
This portion of Yankee Clipper is located in the bus and taxi lane in front of the terminal passenger pick up area. This area has several standing water issues, curb and gutter damage, pavement scars from removed reflectors and old markings, failing patches, pavement cracking, and rutting at the exit. Although this pavement did not score the lowest, the location and use of the road make it rank at the top of the list for rehabilitation need.

It is recommended that the pavement be milled and resurfaced for the majority of the pavement surface. At the exit of the road where rutting and previous patching is evident, it is recommended to reconstruct this area with concrete, in conjunction with Dixie Clipper A. The schematic cost

estimate of construction is \$198,360.

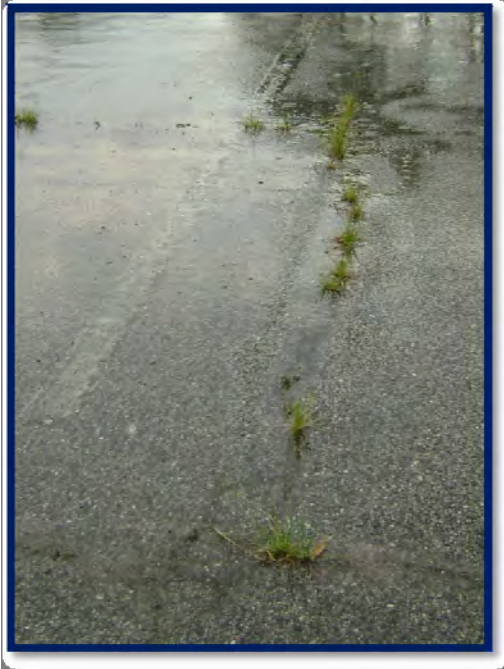
#### 4.1.2.11 Surface Parking Lot A – Approaching Critical Range – PCI 69

Surface Parking Lot A incorporates the majority of the surface parking lot to the south. Structurally the pavement appears to be in good condition. The majority of distress is related to weathering and raveling. There is some surface longitudinal and transverse cracking due to age and thermal expansion and contraction. Some of these cracks have vegetation growing in them. Areas around light pole bases have signs of water infiltration and related failures. Parking space markings are faded to the point where it is hard to determine parking locations.

Much of the distresses found can be mitigated by applying a herbicide and applying a pavement rejuvenator. The pavement rejuvenator will fill in cracks, provide bond for exposed aggregate, and gives the pavement a “new look” with a fresh coat of new paint. This will ultimately

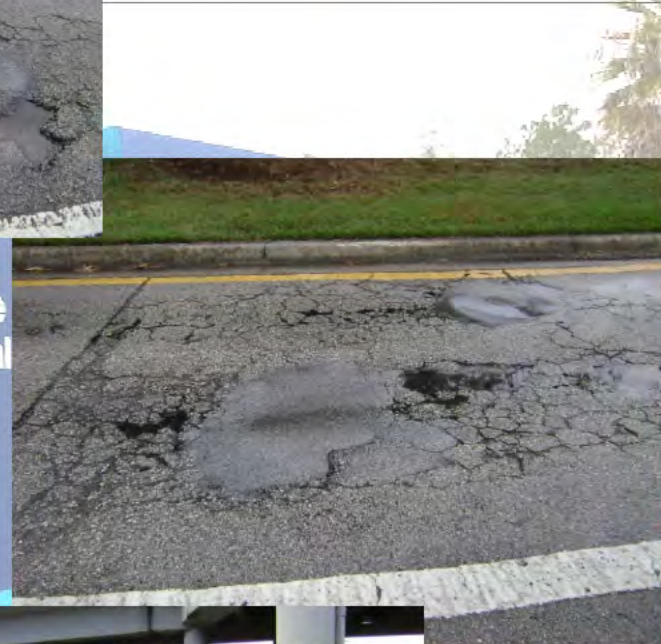
- **Dixie Clipper Road A**
  - PCI 14 (Below Critical)
  - Near parking garage exit by passenger pickup area
  - Heavy traffic and constant start/stop conditions generating point loads
  - Severe Rutting and Alligator Cracking
  - Past patching attempts have failed
- **Recommended Fix - \$40,224**
  - Remove damaged AC pavements and replace with concrete.

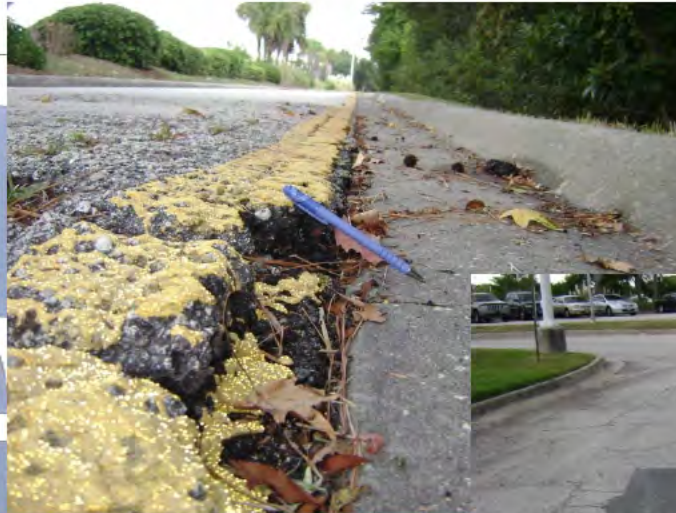
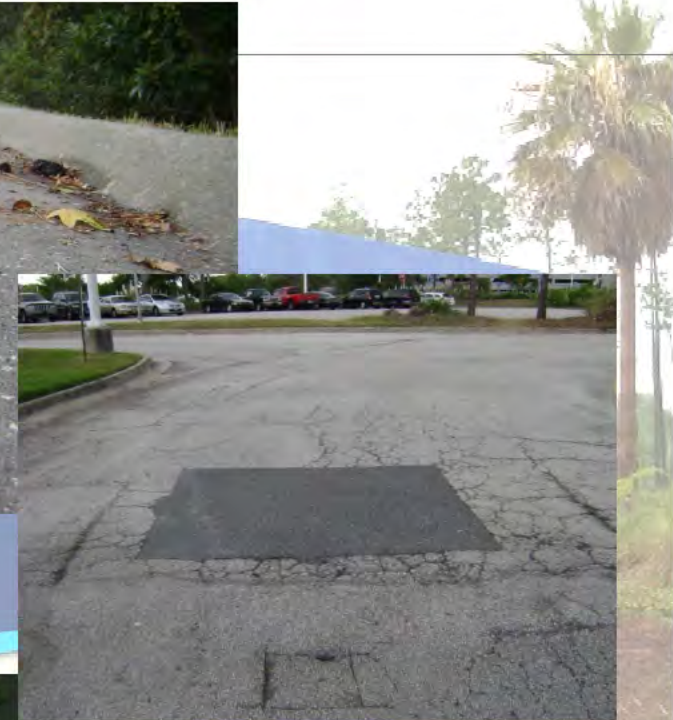
- **Thomas Imeson Ave A**
  - PCI 66 (Critical Range)
  - Entrance to Clarion Hotel
  - Isolated areas of Severe Distress
  - Roots coming up through pavement
  - Very poor ride quality in areas
- **Recommended Fix - \$52,080**
  - Isolated Full Depth Repairs to 40'x12' and 50'x12' areas
  - Remove Large Tree with roots in pavement.
    - Tree has significant rot

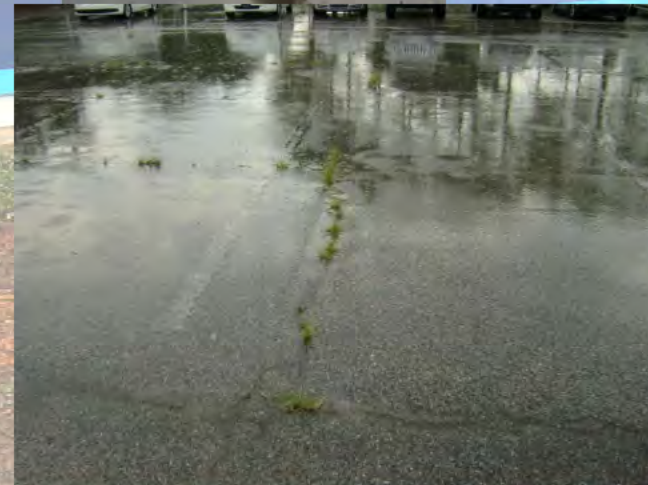
- **Surface Parking Lot A**
  - PCI 69 (Approaching Critical Range)
  - Majority of southern surface lot
  - Good structural condition
  - Most distress related to weathering and age
  - Weeds growing through pavement.
  - Some signs & lighting pole bases allowing infiltration of water.
- **Recommended Fix - \$263,400**
  - Apply Herbicide
  - Seal large cracks
  - Isolated repairs around light poles
  - Apply pavement rejuvenator
