**FINAL REPORT  
LANDSIDE PAVEMENT EVALUATION**

**JAX**  
Jacksonville  
International  
Airport

**JANUARY 2012**

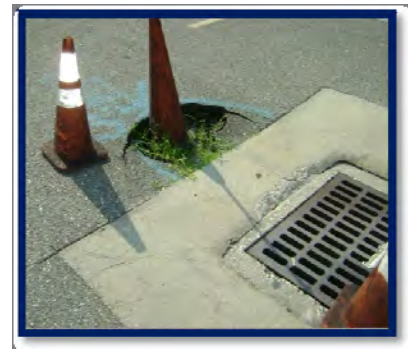
The Air Cargo Lot is primarily used for semi-truck loading and unloading, with a few employee parking spaces. The pavement surface has significant weathering, cracking, and oil drippings. A more concerning issue is the failure located around the in-pavement inlets.

The most expensive and long term recommendation is to mill and resurface the pavement. In addition, repair to the inlets and pavement surrounding them is needed. The schematic cost estimate of construction is \$295,080.

In an effort to slow the deterioration, a less expensive option has been evaluated. In order to extend the pavement life it is recommended to repair/modify inlets, surface seal the pavement, seal large cracks, and full depth repair load failure areas. The schematic cost estimate of construction is \$145,560.

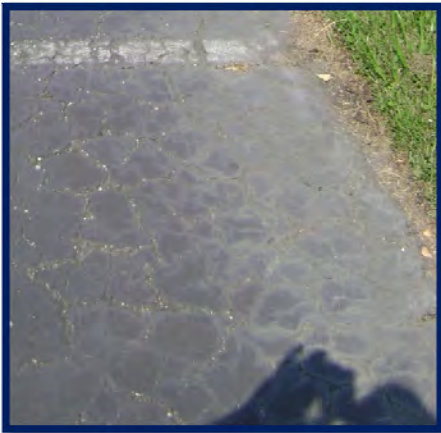
#### **4.1.2.2 Cole Flyer Lot A & B – Below Critical Value – PCI 26 & 54**

The Cole Flyer Lot is located next to a vacant hangar located off of Cole Flyer Road. This lot has been broken up into two separate sections because of different ages of construction between the parking lot and access drive. It appears that the parking spaces next to the hangar were added at a later date. Even though the two pavements are different ages they both have similar distresses and the recommendations are the same.

The pavement area shows signs of surface cracking, which resembles alligator cracking. There is no evidence that this is a load related crack therefore it is not alligator, but it is believed to be a shallow surface or cosmetic crack caused by thermal expansion and contraction differences in the asphalt

and surface seal. Pavement cores should be taken to verify. If the assumptions are correct, a surface seal shall be applied to the entire section. The schematic cost estimate of construction is \$40,128.

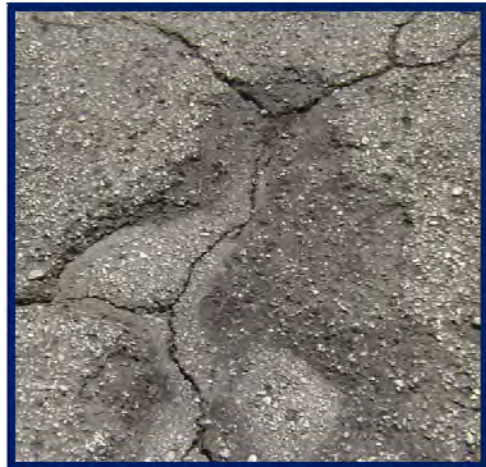
#### **4.1.2.3 Delivery Road B – Below Critical Value – PCI 46**

Delivery Road B is primarily used by vehicles making deliveries to the terminal, landside. Other than the pavement being weathered and aged, there is a location of rutting and alligator cracking near the gate arm. A previous overlay is evident due to the loss in bond between the original pavement and the overlay. The overlay is peeling away in some locations. The overlay appears to be between ½" and ¾" thick.

It is recommended that the pavement be milled and resurfaced. The schematic cost estimate of construction is \$36,456.

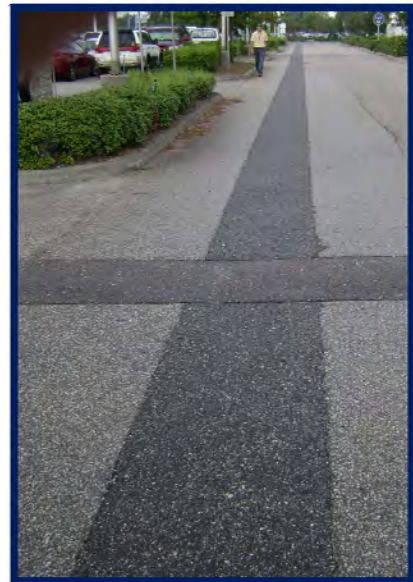
Parking Access Road D is located in the long term surface parking lot. This road is used to access the parking aisles as well as the main road for patrons leaving the parking garage and adjacent parking lot. The road has several utility patches running through it in addition to other isolated areas of distress causing a poor ride quality.

It is recommended that the pavement be milled and resurfaced. Isolated full depth repairs are recommended. The schematic cost estimate of construction is \$60,740.

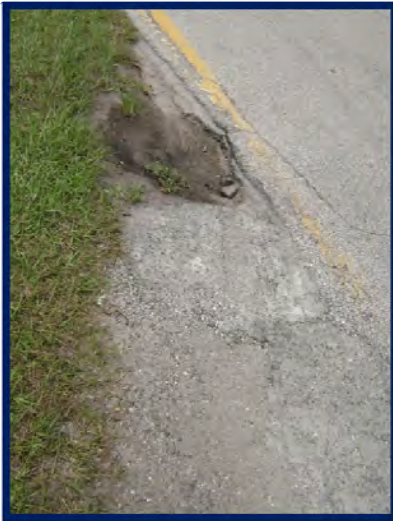
#### 4.1.2.6 Pecan Park A – Below Critical Value – PCI 14

Pecan Park A includes the area where Yankee Clipper and Pecan Park Road connect to the south west. This area has various failing patches, alligator cracking, and the previous overlay is losing its bond to the pavement underneath. In addition, vehicles are leaving the pavement surface and driving on the grass shoulder causing damaged pavement edges.

Primarily, it is recommended to mill and resurface this area. Other possibilities to improve the pavement area include, widening and adding curb and gutter to eliminate vehicles from leaving the pavement. The schematic cost estimate of construction for milling, resurfacing, curb and gutter, and 2' widening is \$52,500.

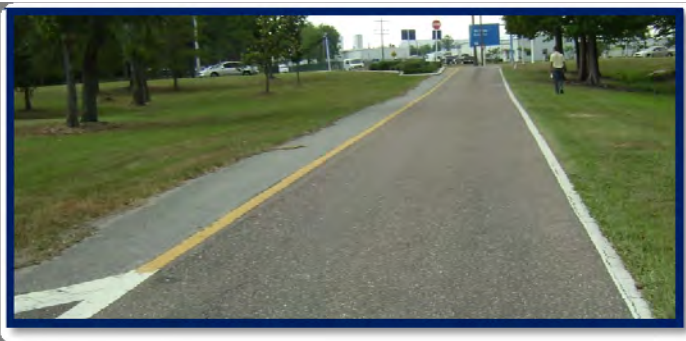
#### 4.1.2.7 Pecan Park C –Critical Range – PCI 57

Pecan Park C includes the straight through section where it ties to Dixie Clipper Dr. This road had a small section of rutting at the stop sign and a failing patched area.

It is recommended that the small area (90'x15') be reconstructed. Another item to consider is shifting the edge markings over by 1'. The pavement width can accommodate the shift and it will help with keeping drivers from leaving the road. The schematic cost estimate of construction is \$24,000.

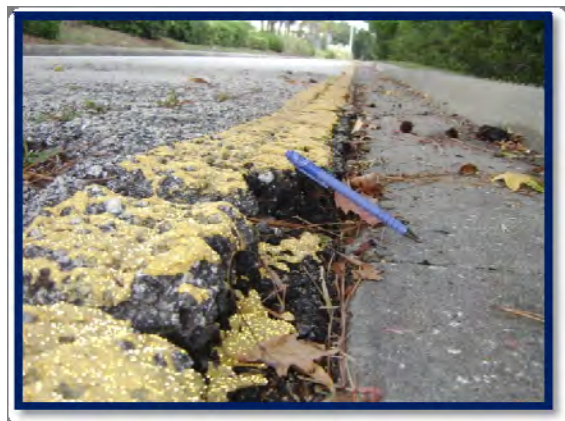
#### 4.1.2.8 Thomas Imeson Ave A – Critical Range – PCI 66

The investigation of Thomas Imeson resulted in isolated areas of severe distresses. There is an area where roots are pushing up the pavement creating a very poor ride quality and also areas of severe alligator cracking at the entrance to the Clarion hotel. These areas are isolated to a 40'x12' and 50'x12' footprint, respectfully.

It is recommended to repair these areas with full depth patches. In addition, the tree causing the damages due to its roots shall be

removed. The schematic cost estimate of construction is \$52,080.

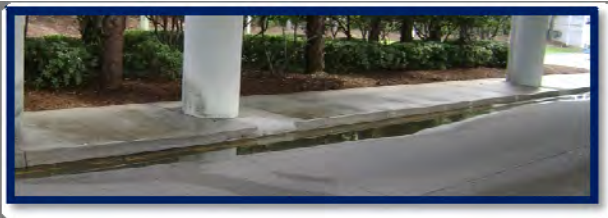
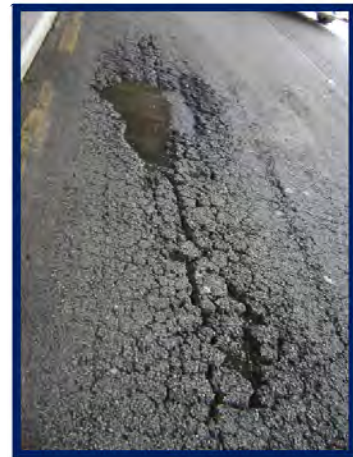
#### 4.1.2.10 Yankee Clipper Rd A-1 – Critical Range – PCI 63

This portion of Yankee Clipper is located in the passenger pick up lane, in front of the terminal under the passenger drop off bridge. This area does not appear to be designed to handle

heavy rainfall since it is under an overpass. During our site visit we found several areas of standing water and pavement distresses caused by standing water. It was determined that the downspout system for the above bridge is rusted and leaking in numerous locations. Prior to completing any pavement rehabilitation project it is a necessity to replace or repair the current downspout system.

The pavement has several areas of standing water and isolated areas of rutting and alligator cracking. Conflicting pavement markings were also found on the pavement which can confuse drivers.

Based on the visual field observations, it is recommended to address the downspout system, mill and resurface the pavement, and adjust grades to control the flow of water.

Given the location and use of the pavement, this area is ranked high on the list for rehabilitation. The schematic cost estimate of construction is \$309,528.

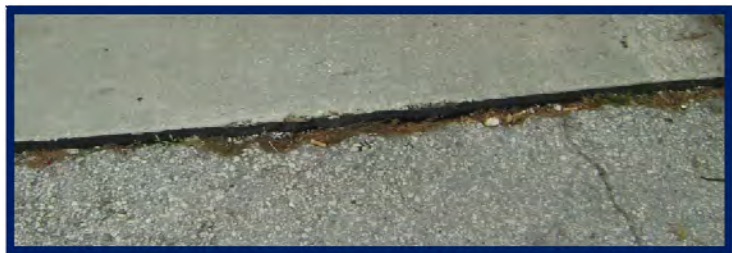
#### 4.1.2.12 Toll Plaza Road C – Approaching Critical Range – PCI 68

The pavement area through the toll plaza shows typical signs of ageing pavement. There are several longitudinal and transverse cracks along with areas of block cracking. At the entrance and exit of the toll plaza, rutting is apparent. Rutting is typical for this location but can be corrected with a thickened pavement section at the transition from asphalt to concrete pavement.

It is recommended that the pavements life could be extended by applying a rejuvenator to the pavement. Thickening the pavement section at the asphalt to concrete transitions is

recommended to prevent further damage to the asphalt as well as protect against edge spalling on the concrete. The schematic cost estimate of construction is \$96,960.

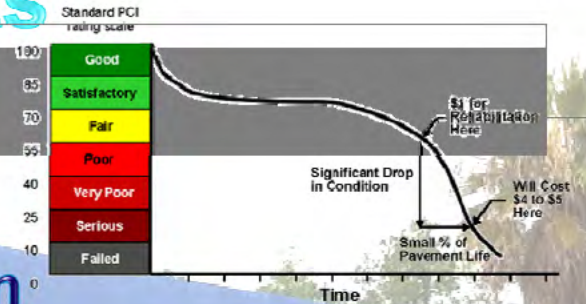
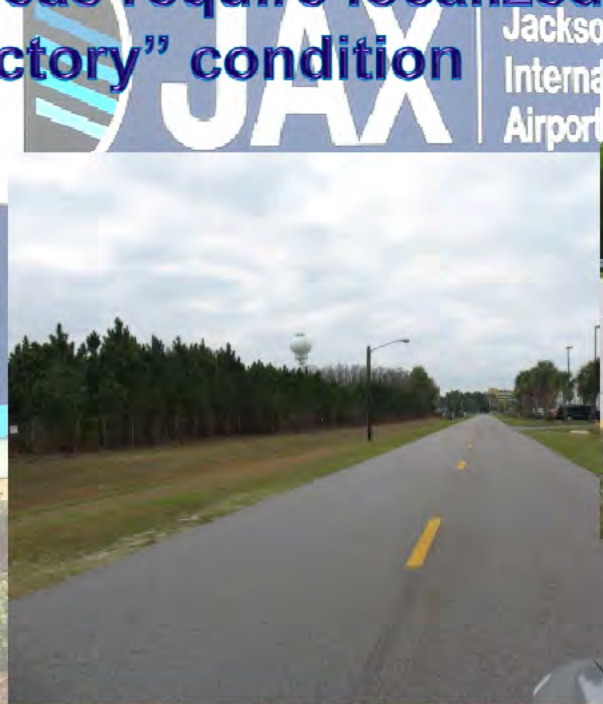
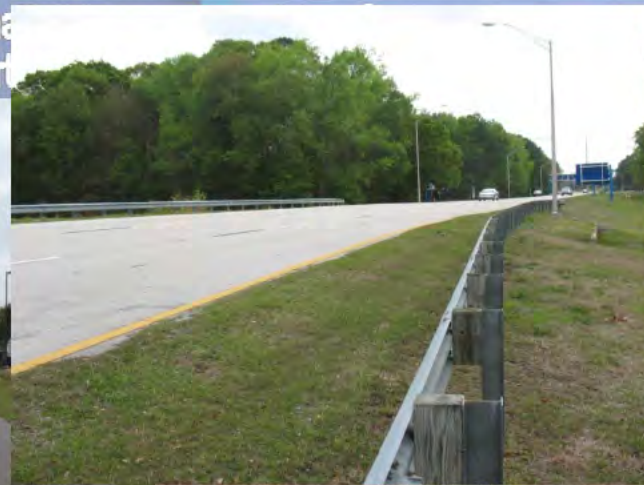
- **Landside Roadways**
  - Generally in “Satisfactory” condition
  - Some areas require localized repairs to return to “Satisfactory” condition

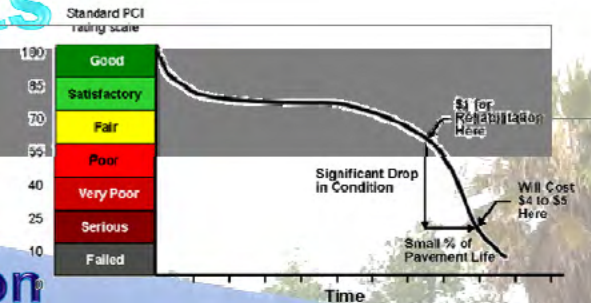
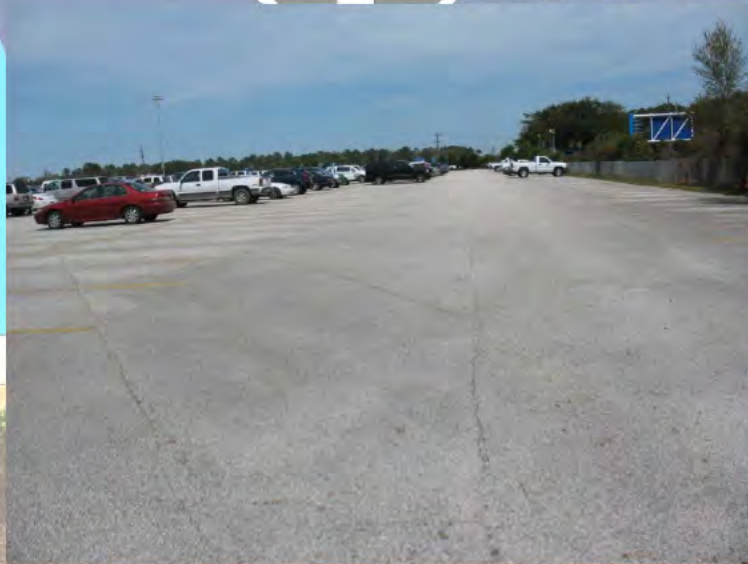
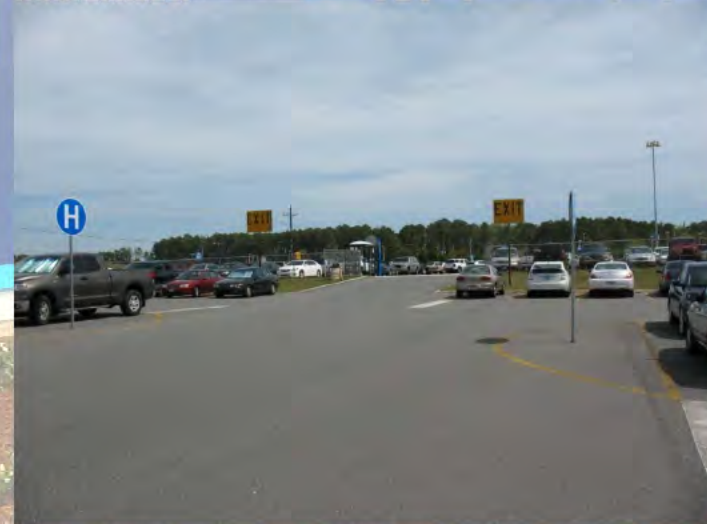
- **Parking Areas**

- Also in typically “Satisfactory” condition
- Some areas require localized repairs, sealing, and pavement rejuvenator or other asphalt emulsion coating

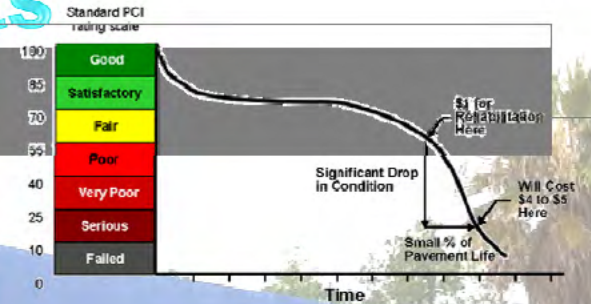
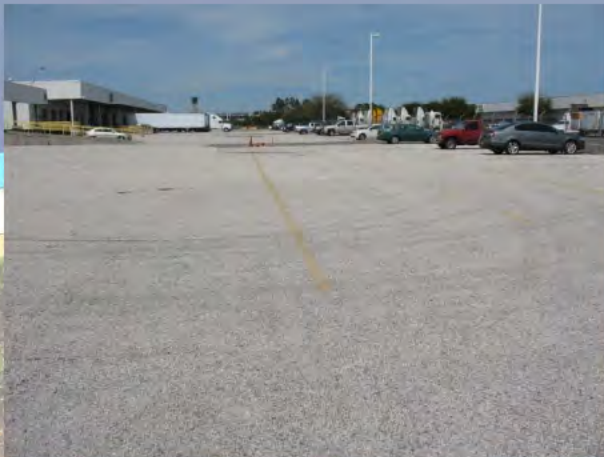
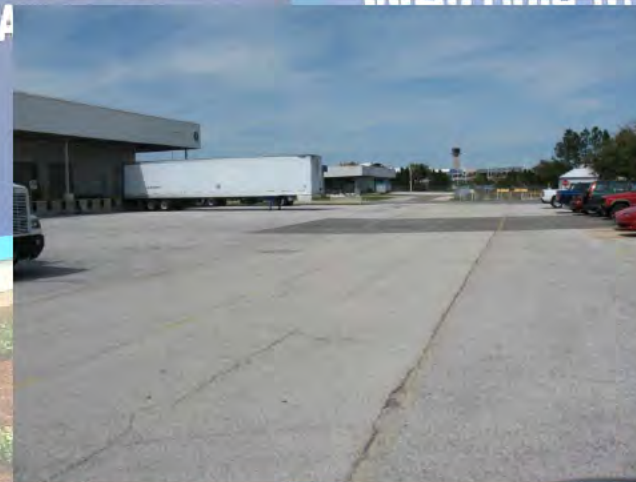
- Cargo & Loading Areas**

- Bottom of the “Fair” condition
- Some areas in critical zone of rapid deterioration
- Major and minor repairs required

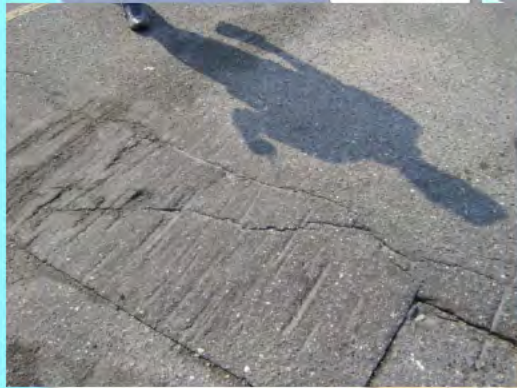
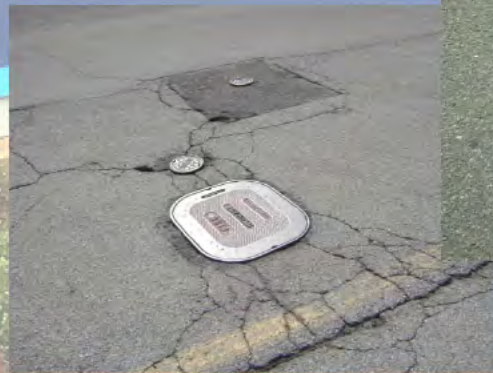
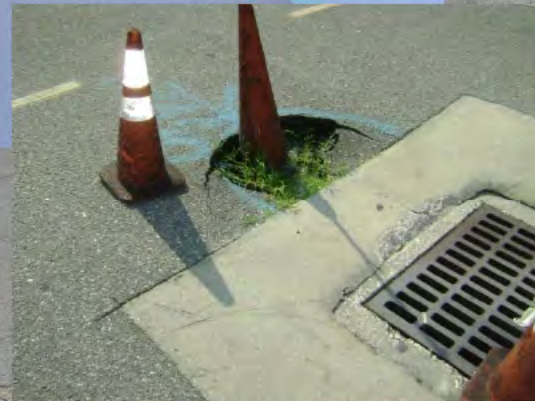
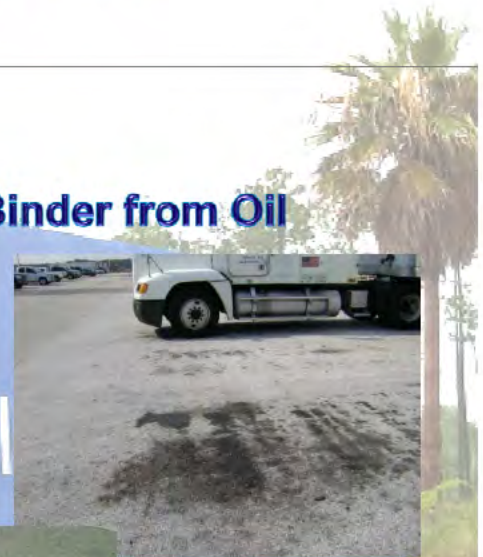
- PCI 52 (Below Critical)
- Significant Weathering, Cracking, and Erosion of Asphalt Binder from Oil Drippings.
- Severe Failure of pavement and subgrade around inlets
- Cars and trucks scraping on failed sections

- **Air Cargo Lot A**
- **Long Term Fix – \$295,080**
  - **Mill & Resurface**
  - **Full Depth Repair of Pavements**
  - **Repair of Pipes and Inlets**
- **Short Term Fix - \$145,560**
  - **Seal Pavement & Cracks**
  - **Repair Around Inlets**
  - **Repair Inlets & Pipes as needed**
  - **Full Depth Repair of Load Failures only**

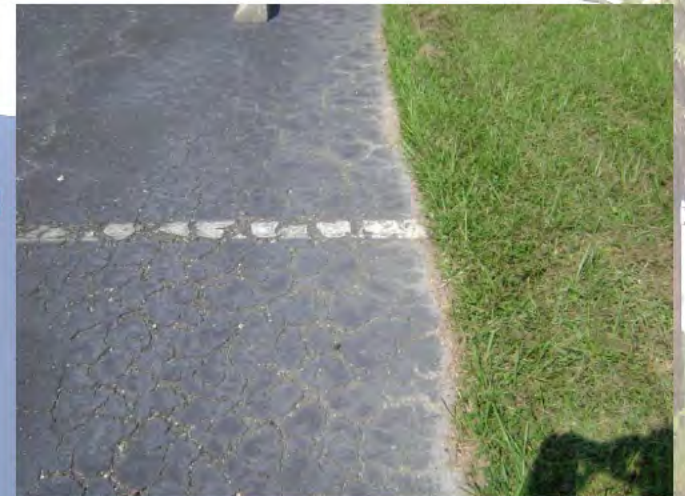
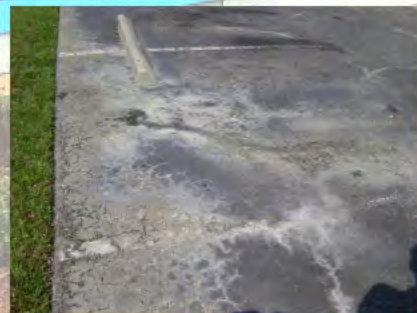
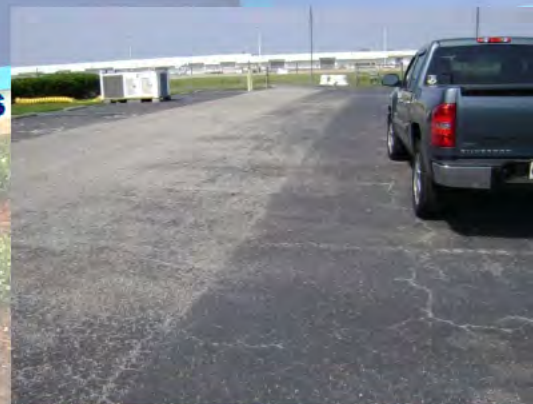
- **Delivery Road B**
  - PCI 46 (Below Critical)
  - Primarily used by delivery trucks to land side terminal
  - Weathering, Alligator Cracking, Rutting.
  - Poorly Bonded Overlay resulting in potholes.
- **Recommended Fix - \$36,456**
  - Mill & Resurface (Select Areas Only)

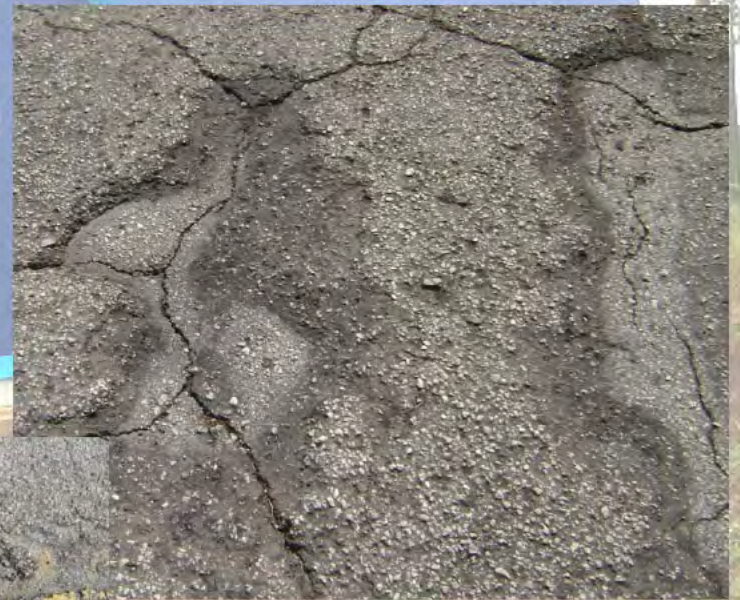
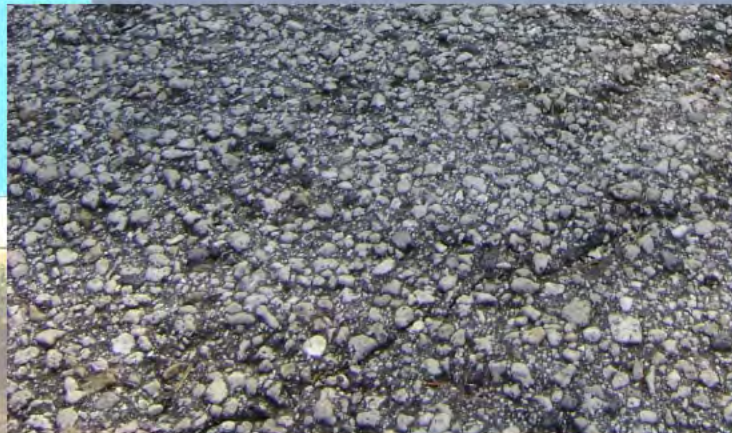
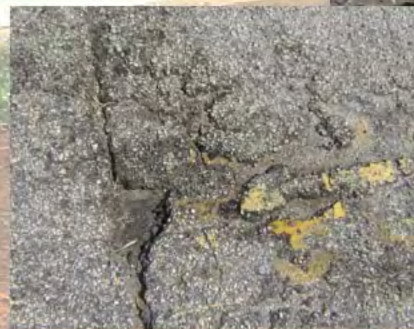
- **Dixie Clipper Road A**
  - PCI 14 (Below Critical)
  - Near parking garage exit by passenger pickup area
  - Heavy traffic and constant start/stop conditions generating point loads
  - Severe Rutting and Alligator Cracking
  - Past patching attempts have failed
- **Recommended Fix - \$40,224**
  - Remove damaged AC pavements and replace with concrete.

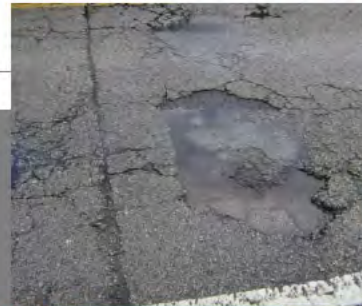
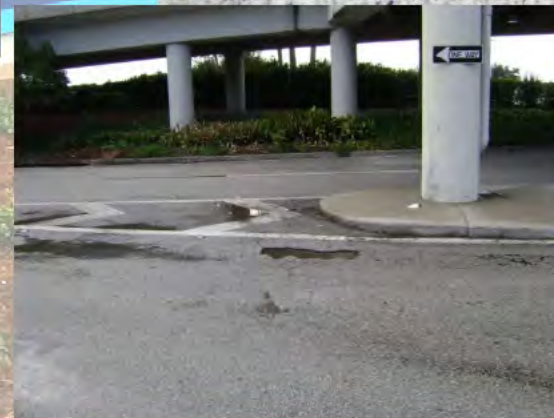
- **Parking Access Road D**
  - PCI 48 (Below Critical)
  - Long Term Surface Lot
  - Numerous Utility Patches
  - Isolated areas of distress causing poor ride quality
- **Recommended Fix - \$60,740**
  - Isolated Full Depth Repairs
  - Mill and Resurface

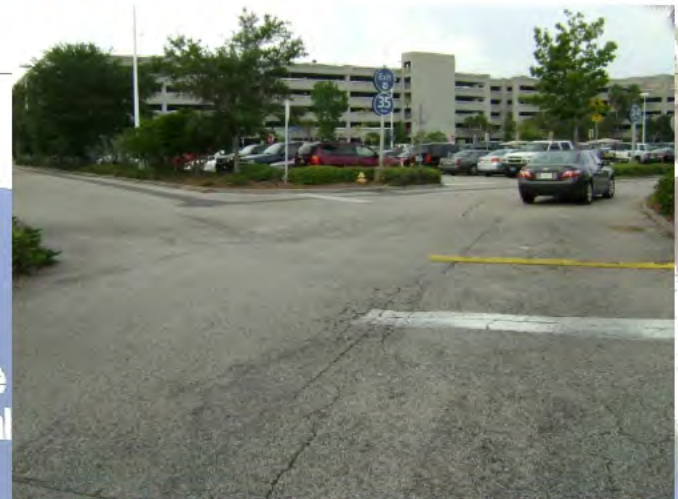
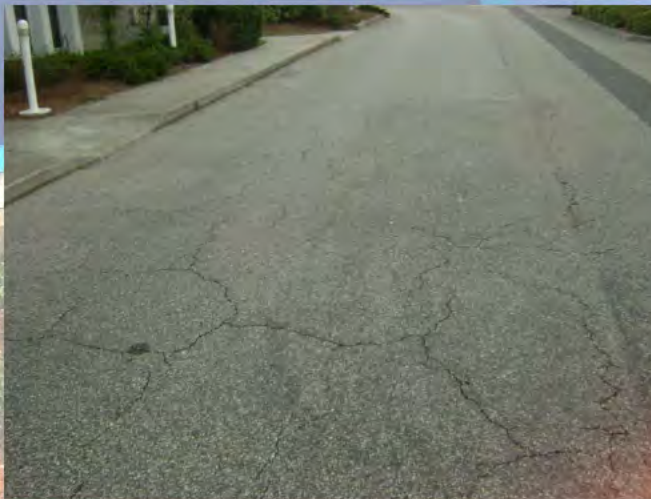
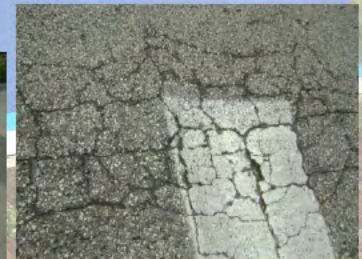
- **Pecan Park A**
  - PCI 14 (Below Critical)
  - Connects Pecan Park to Yankee Clipper
  - Poorly bonded overlay
  - Failing Patches
  - Alligator Cracking
  - Rutting where vehicles leave pavement
- **Recommended Fix - \$52,500**
  - Widen and add Curb & Gutter
  - Mill and Resurface

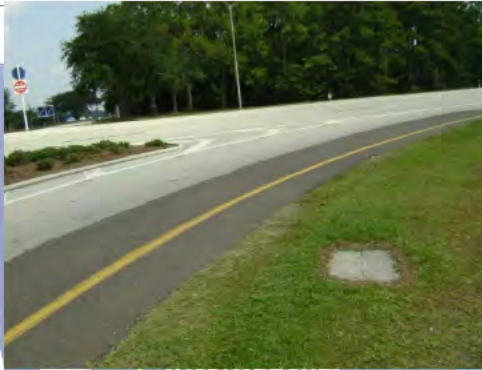
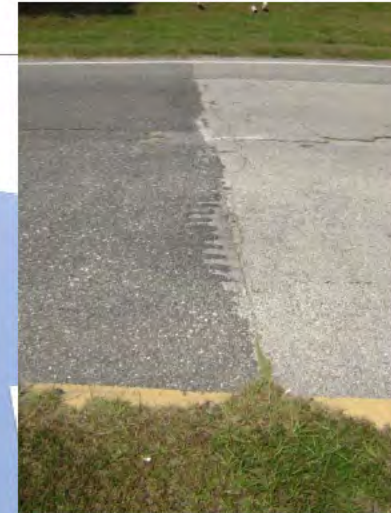
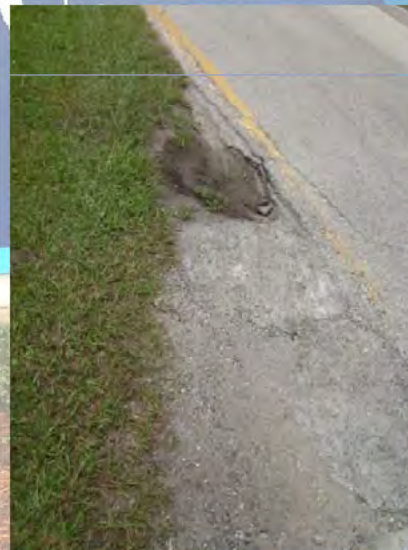
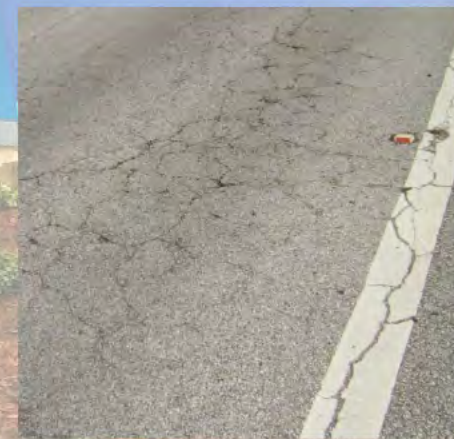
- **Pecan Park C**
  - PCI 57 (Critical Range)
  - Straight stretch to Dixie Clipper Dr.
  - Small section of rutting and failing patches
- **Recommended Fix - \$24,000**
  - Reconstruct 90'x15' area
  - Possibly shift markings 1' southeast to eliminate drivers from leaving roadway.

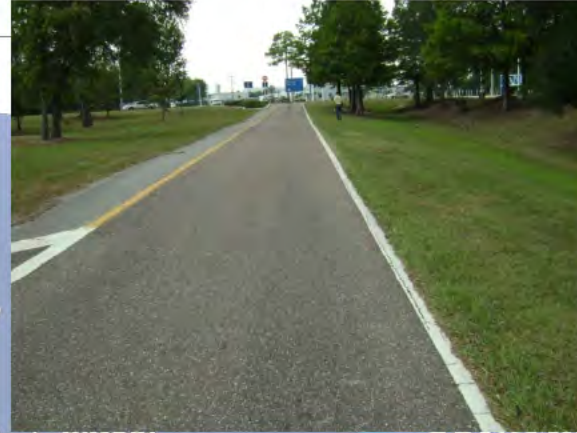
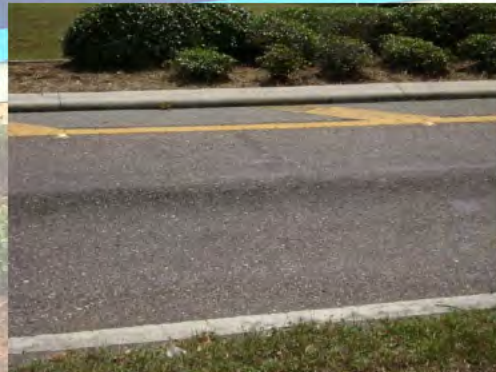
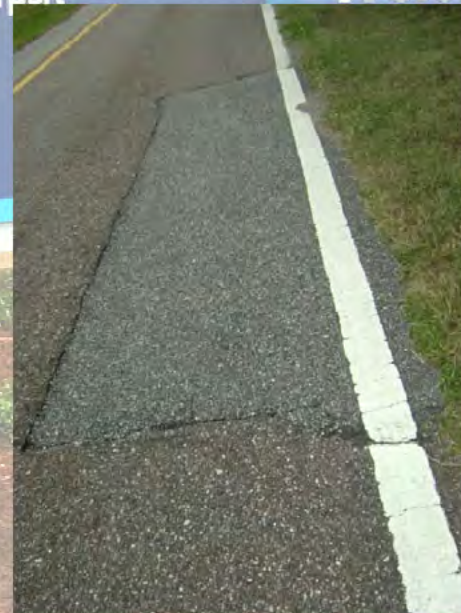
- **Thomas Imeson Ave A**
  - PCI 66 (Critical Range)
  - Entrance to Clarion Hotel
  - Isolated areas of Severe Distress
  - Roots coming up through pavement
  - Very poor ride quality in areas
- **Recommended Fix - \$52,080**
  - Isolated Full Depth Repairs to 40'x12' and 50'x12' areas
  - Remove Large Tree with roots in pavement.
    - Tree has significant rot

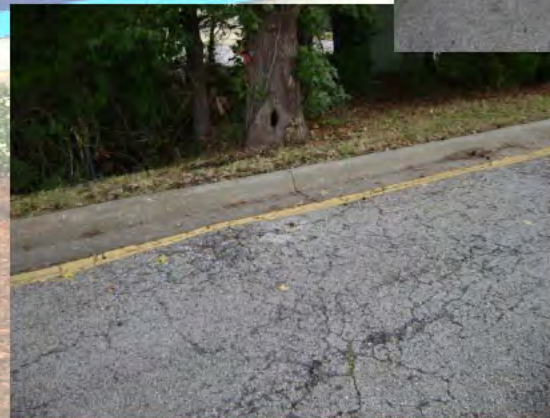
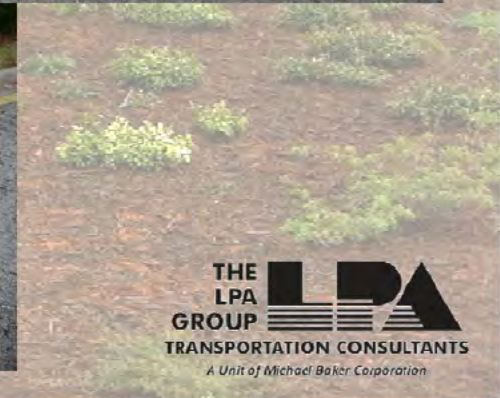
- **Yankee Clipper Rd A**
  - PCI 64 (Critical Range)
  - Bus and Taxi Lane in front of passenger pickup at terminal
  - Standing water, damage to C&G, failing patches, rutting, cracking, pavement scars from removal of markings and reflectors.
- **Recommended Fix - \$198,360**
  - Isolated full depth repairs
  - Mill and resurface
  - Reconstruct exit area with concrete where there is severe rutting and failings patches

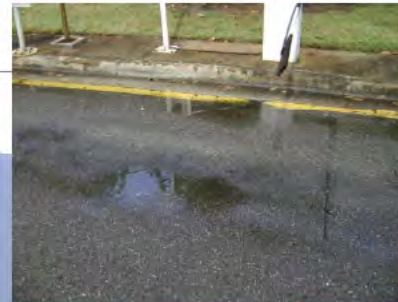
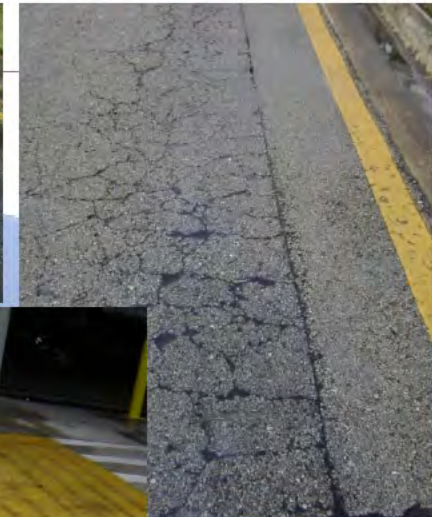
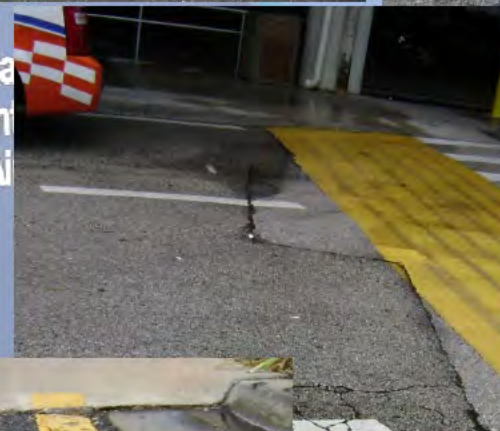
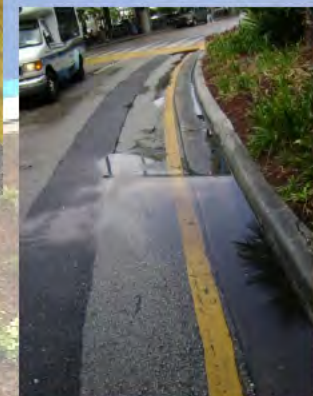
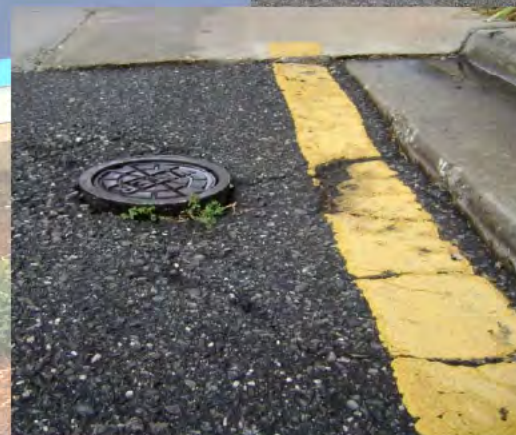
- **Yankee Clipper Rd A-1**
  - PCI 63 (Critical Range)
  - Passenger pickup lanes at terminal
  - Not adequately designed to handle heavy rainfall
  - Observed areas of standing water and distress caused by standing water
  - Downspout & standpipes for bridge severely leaking & need to be replaced or repaired prior to rehab
  - Ranked high on priority list due to location and usage
- **Recommended Fix - \$309,528**
  - **Replace downspout system**
  - **Mill & resurface**
  - **Grade adjustments & levelling to facilitate drainage**

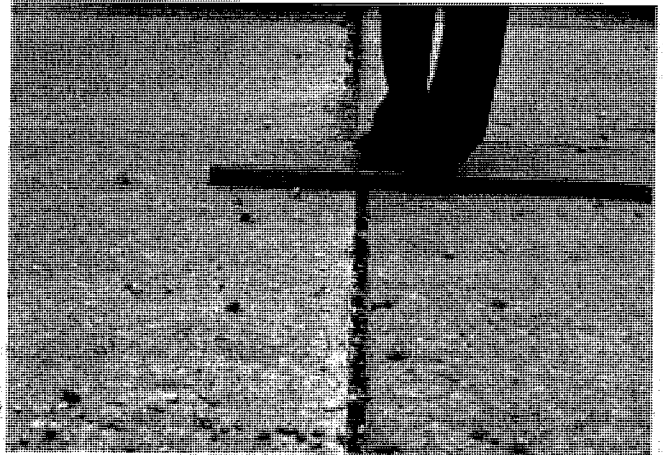
FIG. X2.11 Medium-Severity Durability Cracking

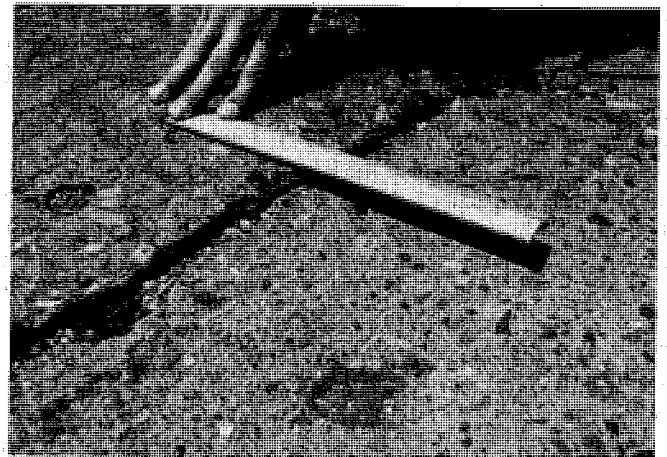
FIG. X2.12 High-Severity Durability Cracking

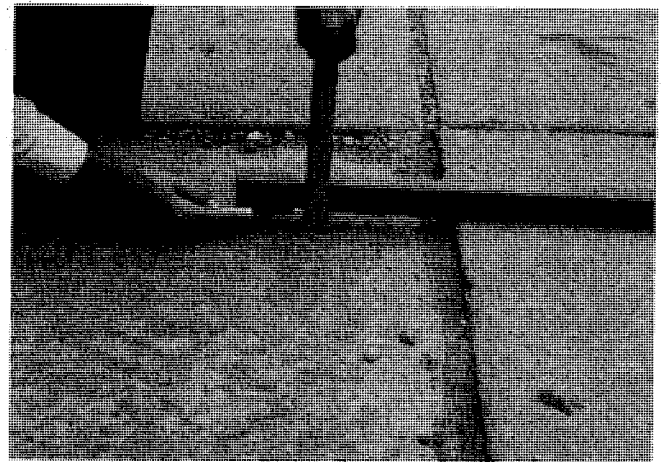
FIG. X2.14 Medium-Severity Faulting

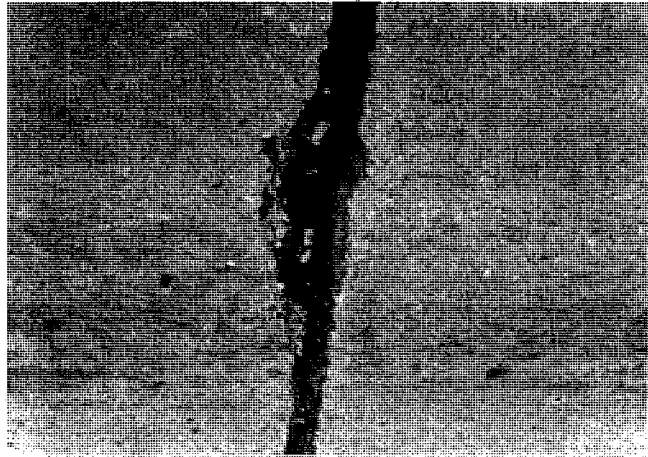
X2.8.2.2 **M**—Joint sealant is in generally fair condition over the entire section, with one or more of the above types of damage occurring to a moderate degree. Sealant needs replacement within two years (Fig. X2.17). Joint seal damage is at medium severity if a few of the joints have any of the following conditions: joint sealer is in place, but water access is possible through visible openings no more than 3 mm (1/8 in.) wide. If a knife blade cannot be inserted easily between sealer and joint face, this condition does not exist; pumping debris are evident at the joint; joint sealer is oxidized and “lifeless” but pliable (like a rope), and generally fills the joint opening; or, vegetation in the joint is obvious but does not obscure the joint opening.

**FIG. X2.17 Medium-Severity Joint Seal Damage**

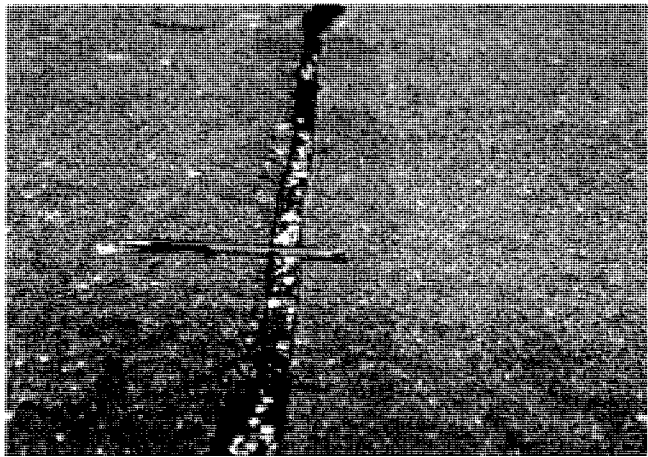
X2.8.2.3 **H**—Joint sealant is in generally poor condition over the entire section, with one or more of the above types of damage occurring to a severe degree. Sealant needs immediate replacement (Fig. X2.18). Joint seal damage is at high severity if 10 % or more of the joint sealer exceeds limiting criteria listed above or if 10 % or more of sealer is missing.

**FIG. X2.18 High-Severity Joint Seal Damage**

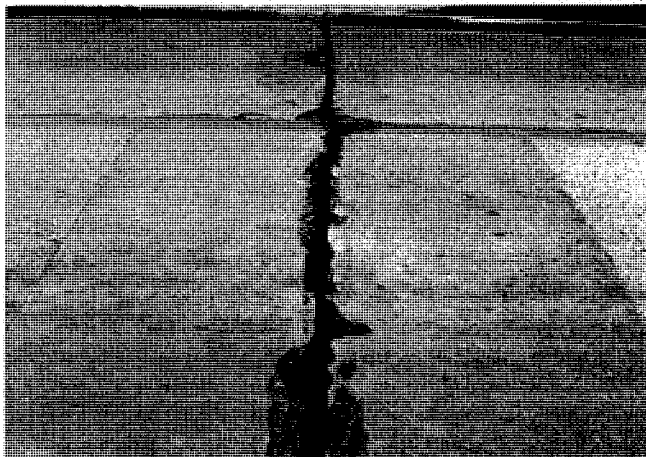
X2.8.2.1 **L**—Joint sealant is in generally good condition throughout section (Fig. X2.16). Sealant is performing well, with only minor damage (see X2.8.1.1-X2.8.1.6). Joint seal damage is at low severity if a few of the joints have sealer, which has debonded from, but is still in contact with, the joint edge. This condition exists if a knife blade can be inserted between sealer and joint face without resistance.

**FIG. X2.16 Low-Severity Joint Seal Damage**

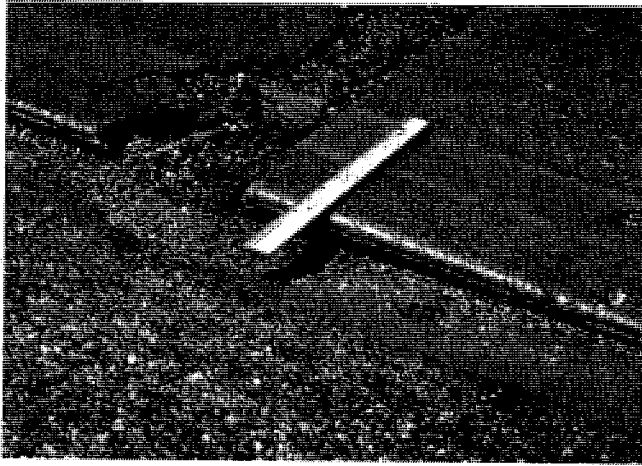
FIG. X2.19 Low-Severity Lane/Shoulder Drop-Off

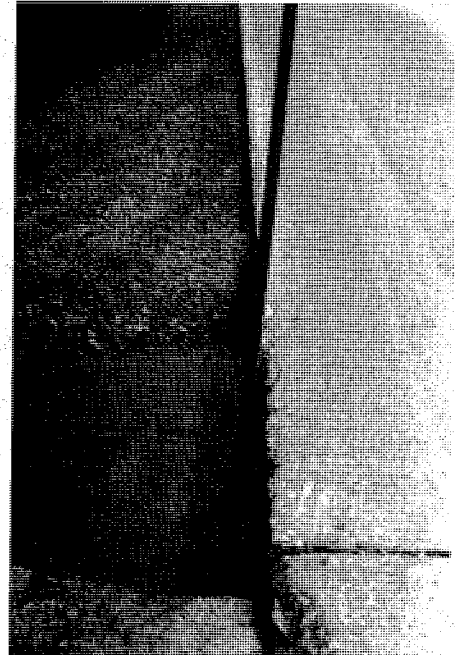
FIG. X2.21 High-Severity Lane/Shoulder Drop-Off

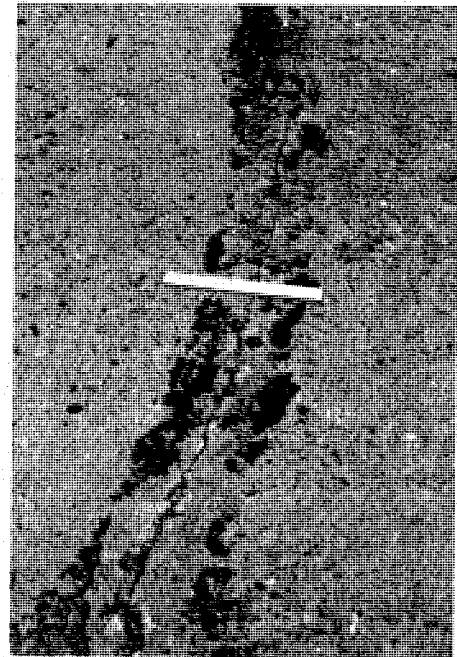
FIG. X2.22 Low-Severity Linear Cracking

**X2.10.1.1 L**—Nonfilled<sup>4</sup> cracks  $\leq 13$  mm ( $\leq 1/2$  in.) or filled cracks of any width with the filler in satisfactory condition. No faulting exists (Fig. X2.22).

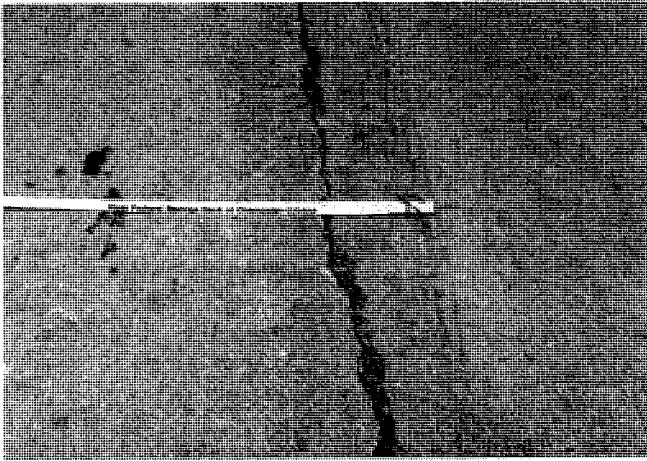
**X2.10.1.2 M**—One of the following conditions exists: non-filled crack with a width  $>13$  and  $\leq 50$  mm ( $>1/2$  and  $\leq 2$  in.); nonfilled crack of any width  $\leq 50$  mm (2 in.) with faulting of  $<10$  mm ( $3/8$  in.), or filled crack of any width with faulting  $<10$  mm ( $3/8$  in.) (Fig. X2.23).

FIG. X2.23 Medium-Severity Linear Cracking

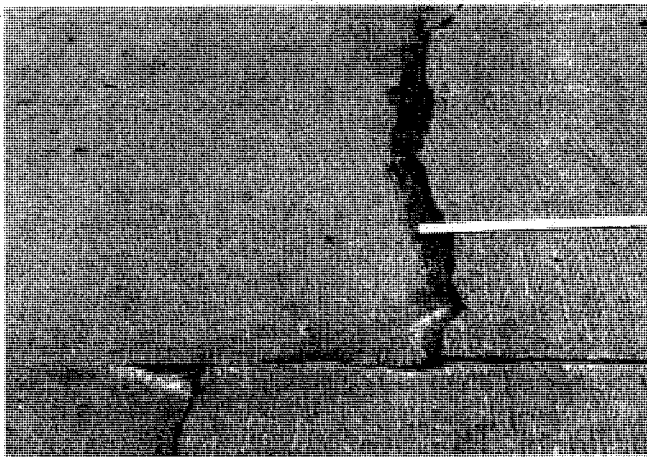
**X2.10.1.3 H**—One of the following conditions exists: non-filled crack with a width  $>50$  mm (2 in.), or filled or nonfilled crack of any width with faulting  $>10$  mm ( $3/8$  in.) (Fig. X2.24).

FIG. X2.24 High-Severity Linear Cracking

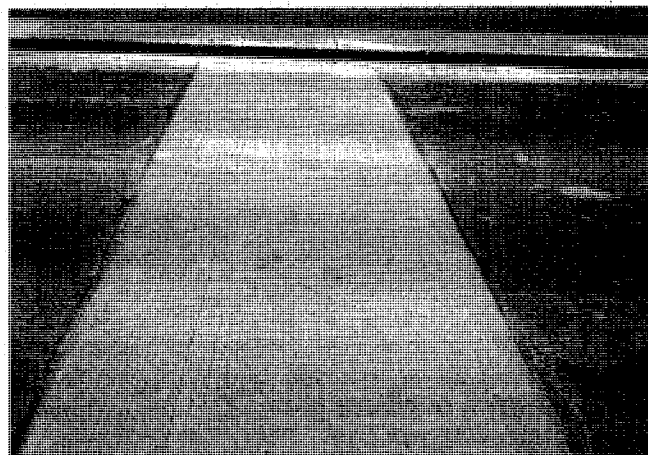
X2.11.1.1 **L**—Patch is functioning well, with little or no deterioration (Fig. X2.25).

FIG. X2.25 Low-Severity Patching, Large and Utility Cuts

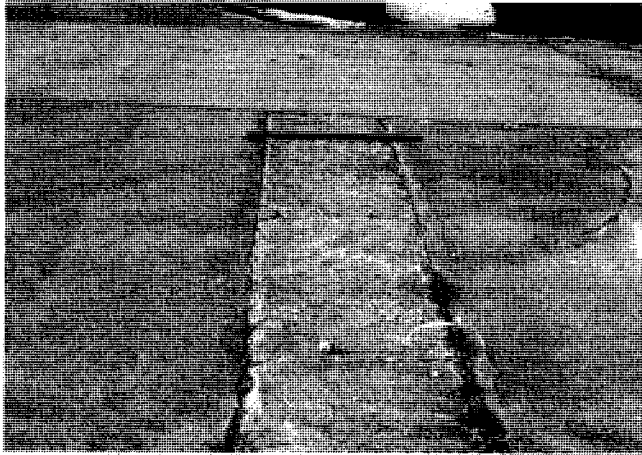
X2.11.1.2 **M**—Patch is moderately deteriorated, or moderate spalling can be seen around the edges, or both. Patch material can be dislodged with considerable effort (Fig. X2.26).

FIG. X2.26 Medium-Severity Patching, Large and Utility Cuts

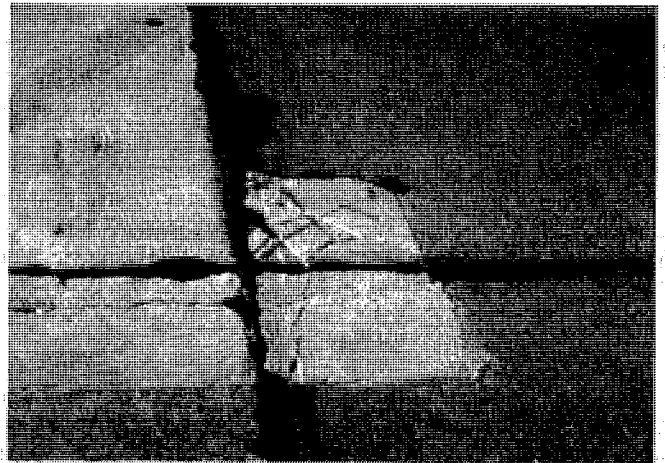
X2.12.1.2 **M**—Patch is moderately deteriorated. Patch material can be dislodged with considerable effort (Fig. X2.29).

FIG. X2.29 Medium-Severity Patching, Small

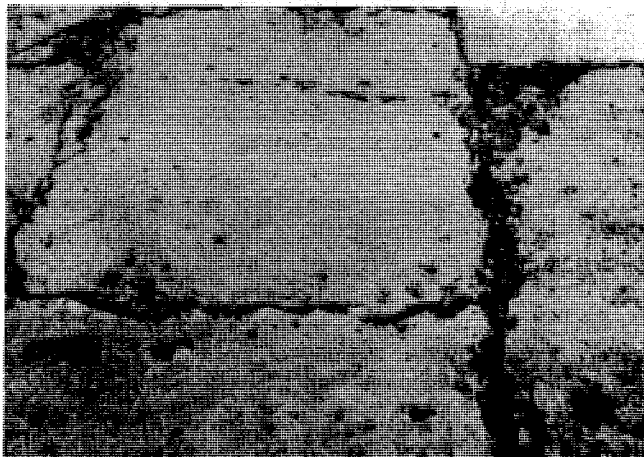
X2.11.1.3 **H**—Patch is badly deteriorated. The extent of the deterioration warrants replacement (Fig. X2.27).

FIG. X2.27 High-Severity Patching, Large and Utility Cuts

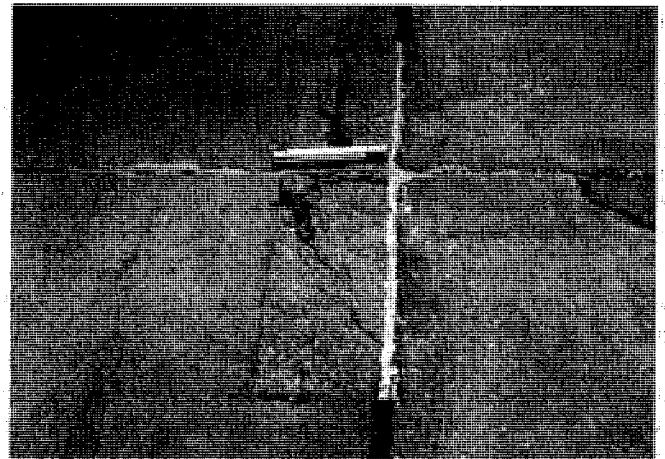
X2.12.1.3 **H**—Patch is badly deteriorated. The extent of deterioration warrants replacement (Fig. X2.30).

FIG. X2.30 High-Severity Patching, Small

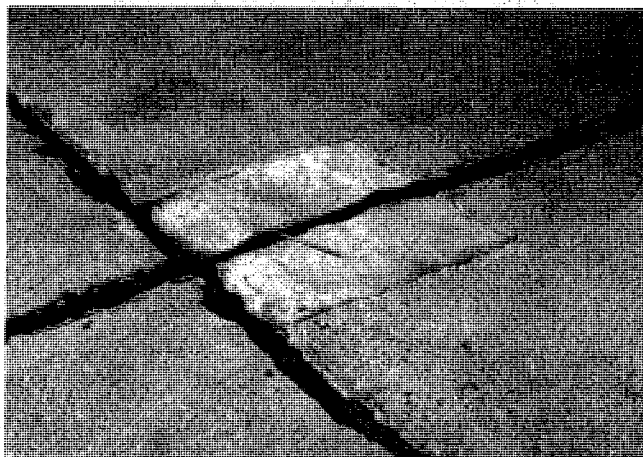
X2.12.1.1 **L**—Patch is functioning well with little or no deterioration (Fig. X2.28).

FIG. X2.28 Low-Severity Patching, Small

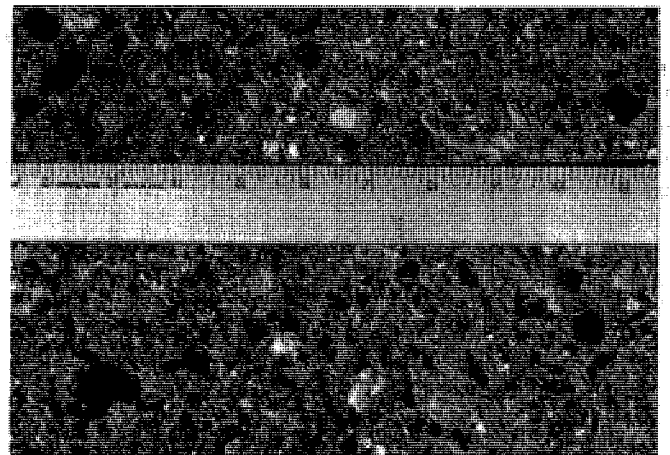
FIG. X2.31 Polished Aggregate

X2.13.1 *Severity Levels*—No degrees of severity are defined; however, the degree of polishing should be significant before it is included in the condition survey and rated as a defect (Fig. X2.31).

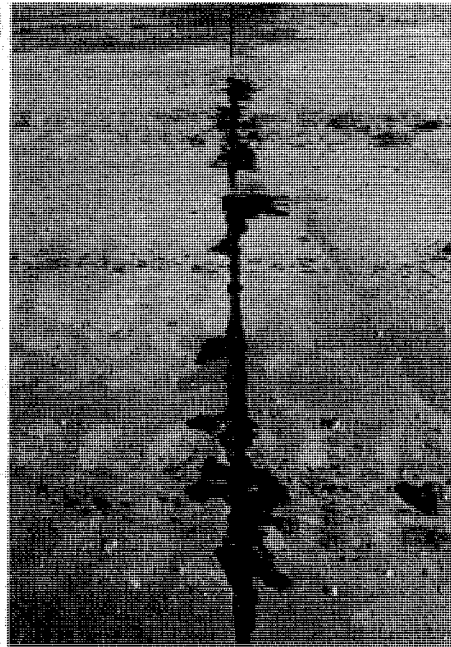
FIG. X2.33 Pumping

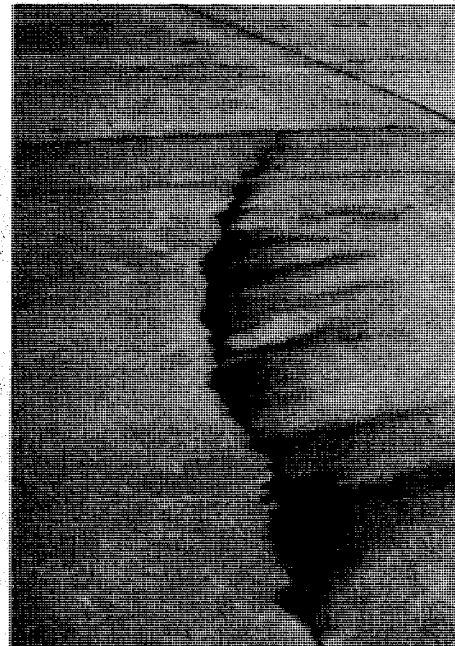
FIG. X2.34 Pumping

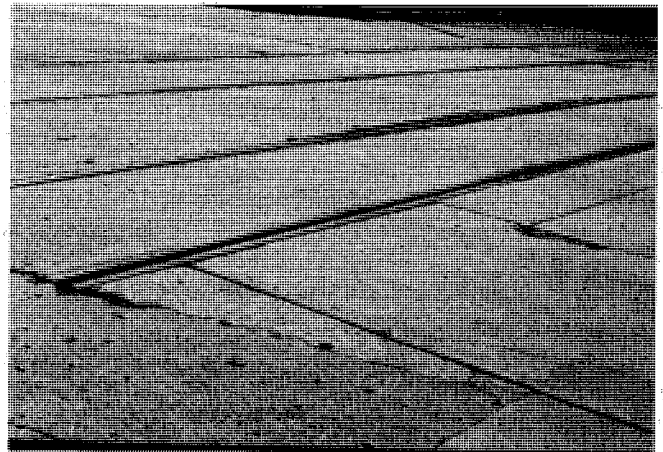
FIG. X2.38 Low-Severity Railroad Crossing

X2.17.1.1 **L**—Railroad crossing causes low-severity ride quality (Fig. X2.38).

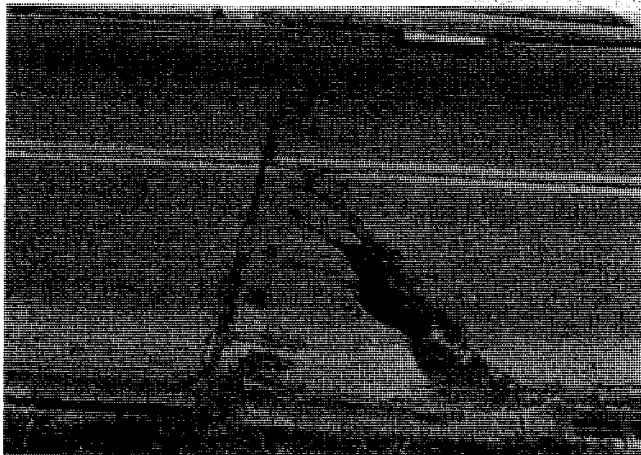
FIG. X2.36 Medium-Severity Punchout

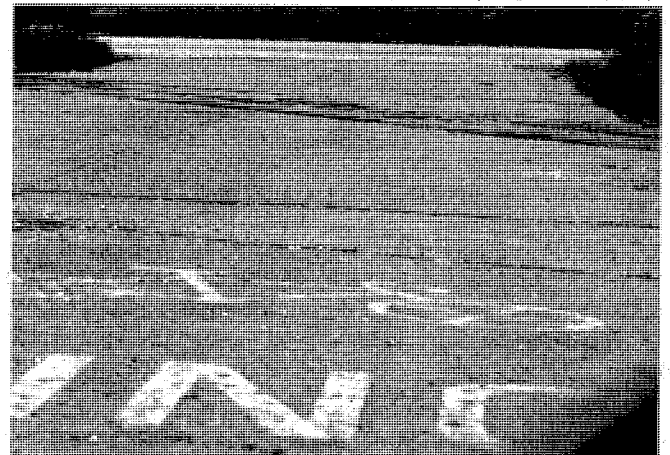
FIG. X2.39 Medium-Severity Railroad Crossing

X2.17.1.2 **M**—Railroad crossing causes medium-severity ride quality (Fig. X2.39).

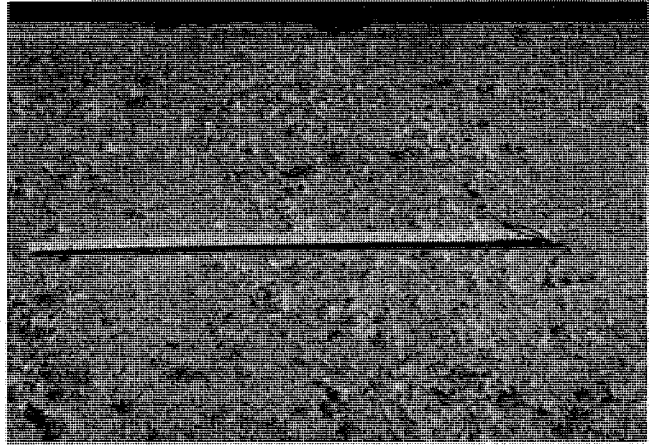
FIG. X2.42 Medium-Severity Scaling, Map Cracking, and Crazing

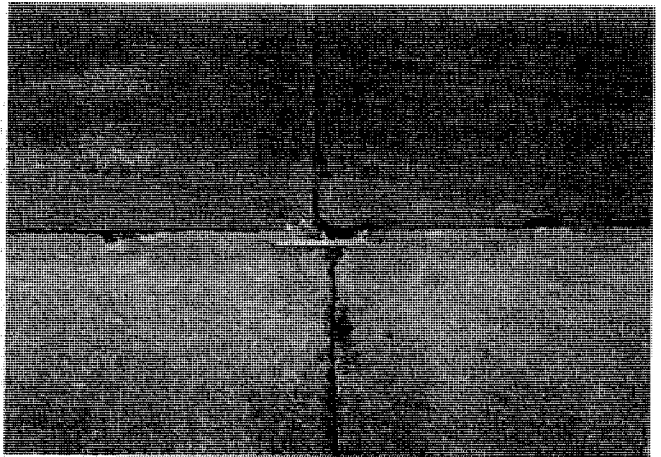
**FIG. X2.45 Low-Severity Spalling, Corner**
