**FINAL REPORT  
LANDSIDE PAVEMENT EVALUATION**

**JAX**  
Jacksonville  
International  
Airport

**JANUARY 2012**

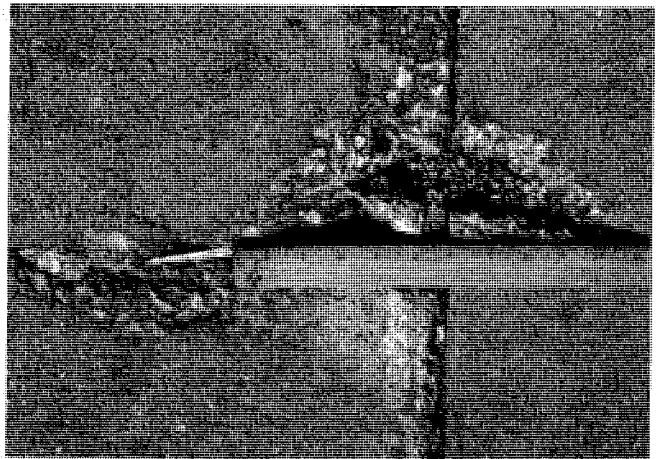
**FIG. X2.46 Medium-Severity Spalling, Corner**

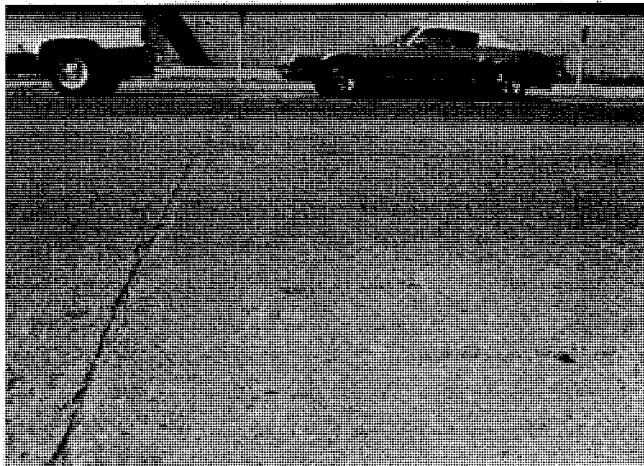
FIG. X2.48 Low-Severity Spalling, Joint

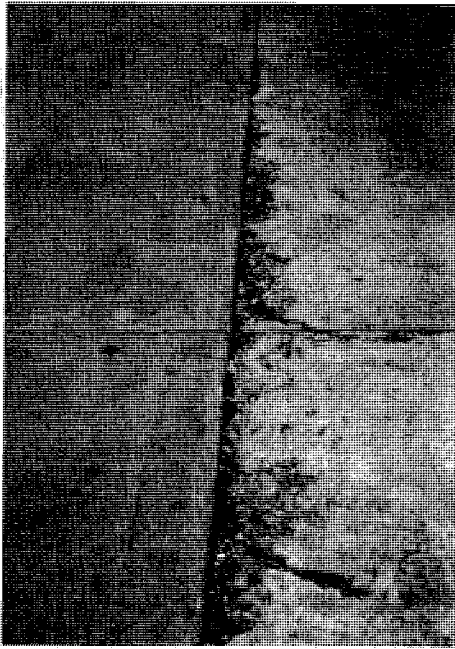
FIG. X2.49 Medium-Severity Spalling, Joint

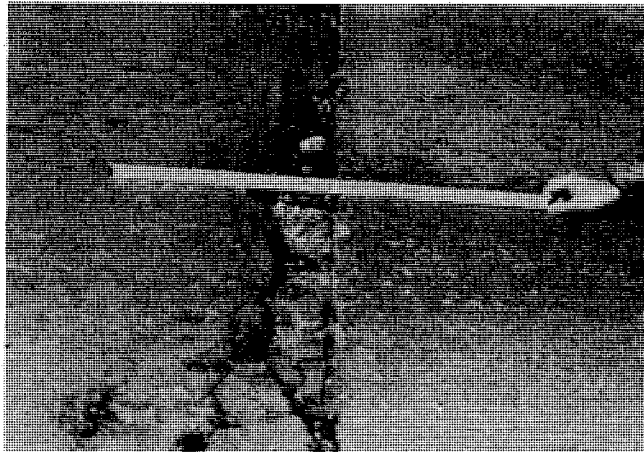
FIG. X2.50 High-Severity Spalling, Joint
